ABBREVIATED PRELIMINARY ASSESMENT

GRANITE CREEK MINE #5

Wallowa-Whitman National Forest
Grant County, OR

August 2006

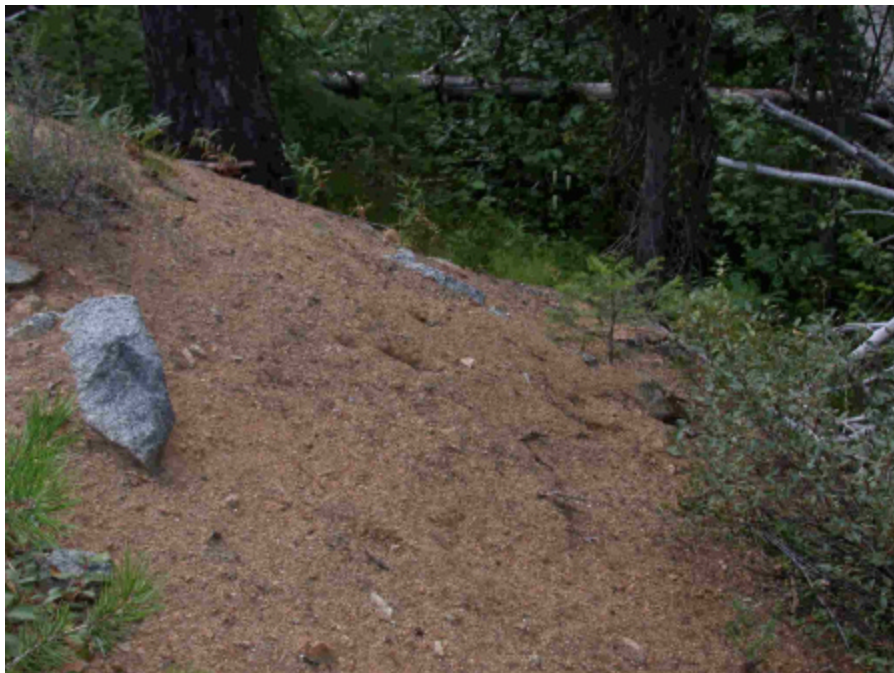
Photo 4. Wasterock along Granite Creek. (Photo by D. Boles)

- One large collapsed adit and approximately 500cy of wasterock
 - There was no evidence of water seeping from the collapsed adit.
 - There are numerous dozer cuts, possibly a second adit above the first and apparent hydraulic mining activity in the area.
 - Wasterock forms part of the bank for Granite Creek.
 - It is obvious that material laced with arsenic is being deposited into Granite Creek by erosion processes and scouring of the toe by Granite Creek.

Since the wasterock forms part of the embankment for Granite Creek, obvious erosion of material entering Granite Creek during rain and snowmelt events, scouring of the wasterock by Granite Creek, and because arsenic has been identified in Granite Creek as exceeding Oregon Department of Environmental Quality freshwater screening criteria (EA Site Inspection, 2004), this Site has been given a High Priority for conducting a Site Inspection and possible removal action.
